Kyle Plumbing  
service@kyleplumbing.com  
5 Southeast 9th Street  
Deerfield Beach, FL 33441  
(888) 405-0770

## Constant backups and stoppages. - Mar 05, 2026

1234 Street St.  
Boca Raton, FL 33333

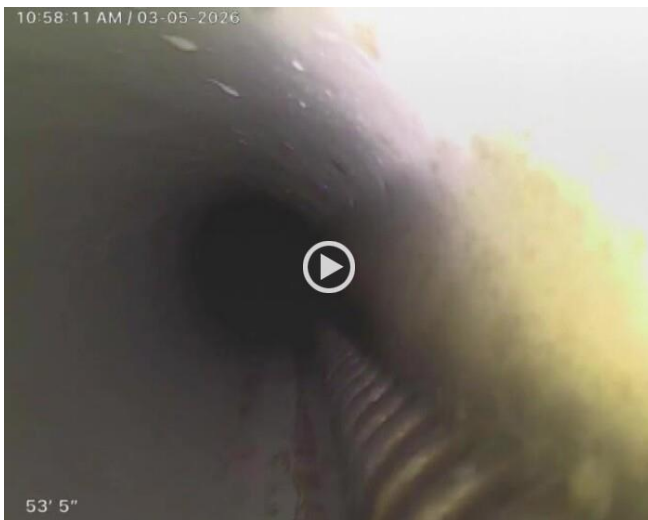
The second camera inspection revealed significant calcium build-up from urine calcification inside the pipeline. This accumulation is likely contributing to the blockage and may impact long-term system performance.

After Clearing Stoppage/ Calcium Build Up

It is recommended to use a Picote machine to break up the calcium build-up, followed by hydro jetting to thoroughly clean the line. Additionally, removing tile and cutting concrete to expose the line is necessary to address the belly by replacing up to 10 feet of piping. A cleanout should be installed for future maintenance and service.

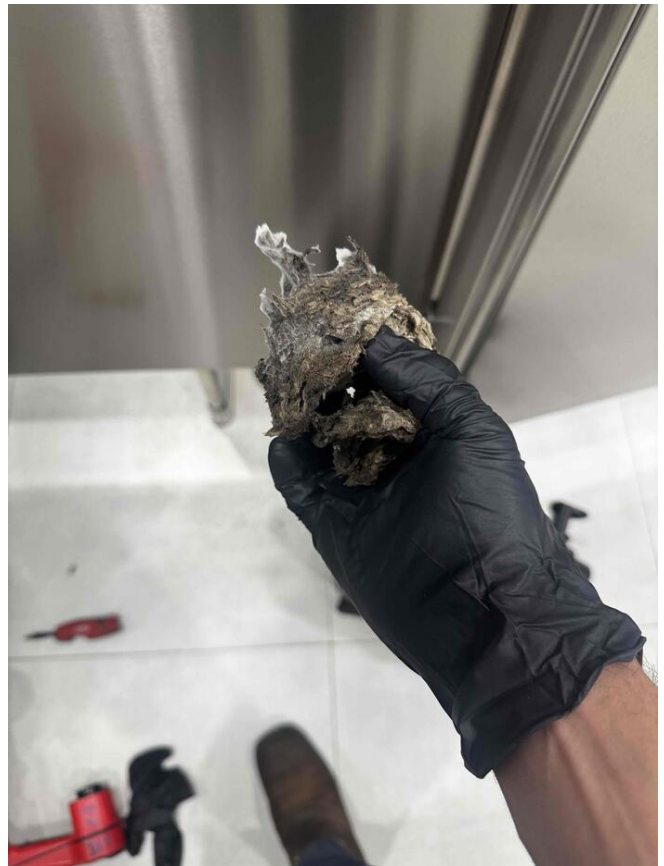
An active stoppage was discovered during the initial camera inspection. A snake was used to clear the line, restoring some flow. Discovered paper towels and other unknown debris. Following this, a second camera inspection was performed.

Paper Towels
